Assessing the instability of Dong Nai River in Bien Hoa District using Bank Erosion Hazard Index (BEHI) and Remote Sensing and GIS

Abstract: In this study, a method for developing a quantitative prediction of river bank erosion in Bien Hoa district in Dong Nai River is presented. The river bank erosion hazard index (BEHI) was estimated to assess the stability of the river bank erosion in consultation with bank height, bank slope, rooting depth, rooting density and surface protection. The estimated BEHI of Dong Nai River in Bien Hoa district are high which indicates the riverbank instability. The estimated BEHI along the left bank is about 25-30. The satellite data of LANSAT TM 5, LANDSAT ETM 7 for the year 1995, 2005 and 2015 were used to assess the nature of shifting of the river bank and to estimate the land loss from river bank. All the derived images were transported on GIS environment to extract the course of the river. 13 sites were considered along the Dong Nai River in Bien Hoa District to estimate the leftward shifting of the bank line and to assess the shifting distance of the river bank line. There is a strong relationship between bank instability BEHI, shifting distanc

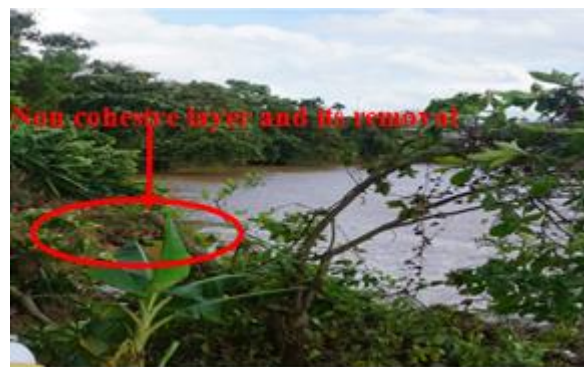
Figure 2. Cohesive and non-cohesive layers at Dong Nai River

Under cutting or loss of underlying support is the primary cause of bank erosion at Dong Nai River. As a result of hydraulic action, the soil particles of underlying layer is detached and carried far away by stream flow which results in overhanging layer at the top. This overhanging layer with time collapse and execute rapid bank erosion.

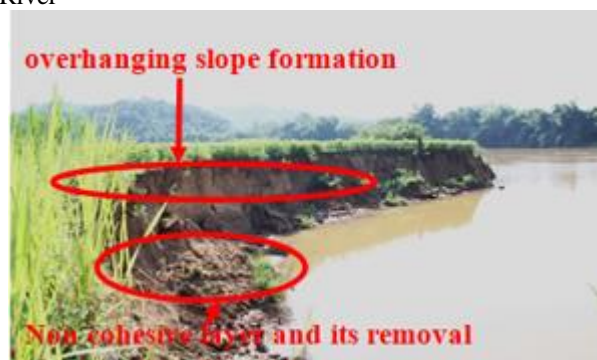
Figure 3. Cohesive and non-cohesive layers at Dong Nai River

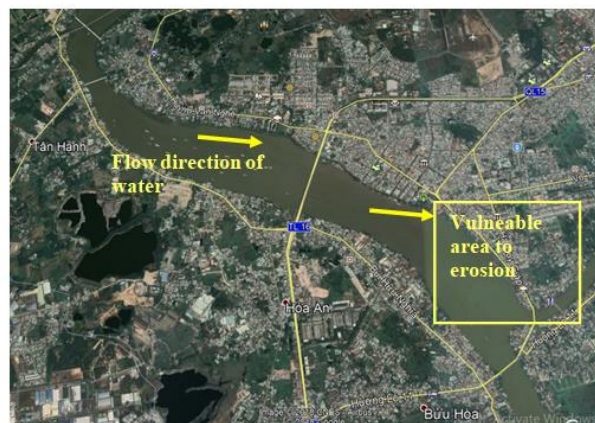
Figure 6: Vulnerable sites of bank erosion at Buu Long - Bien Hoa.
